**WA-V-069**

**Meadow Brook Farm**

**Williamsport Vicinity**

## INVENTORY FORM FOR STATE HISTORIC SITES SURVEY

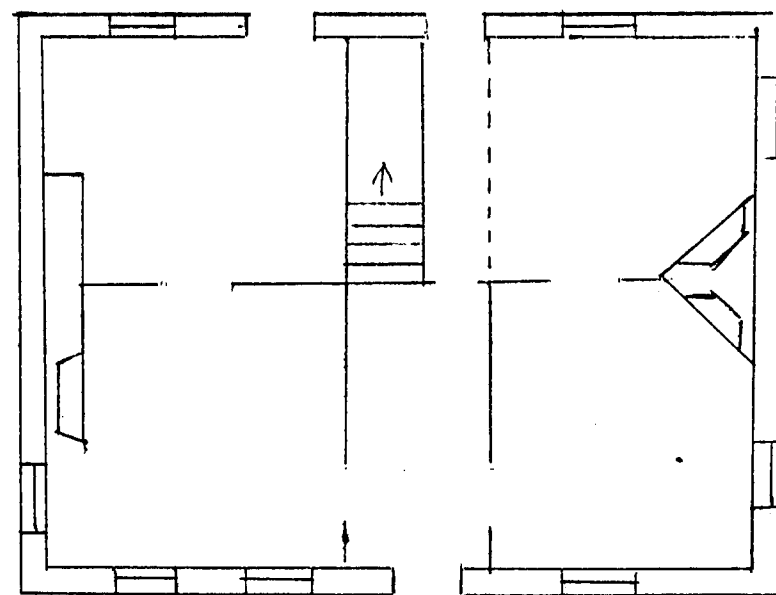
ROUGH SKETCH OF FIRST FLOOR PLAN

The interior of the house at the first story consists of four rooms divided by an entrance and stair hall. The two rooms located east of the hall each have diagonal fireplaces with relatively plain trim. West of the hall is a parlor and a secondary room. The parlor displays a partially paneled chimney wall with an unusual type of applied molded trim which appears at initial observation to be original. Cornice molding in the parlor room also appears to be original. The mantel piece is embellished with fluted and reeded work. All interior doors have six raised panels finished with quarter round. Interior door and window trim in the major rooms has "dog ear" or "shouldered" molding at the upper corners. A large service fireplace is located in the cellar.

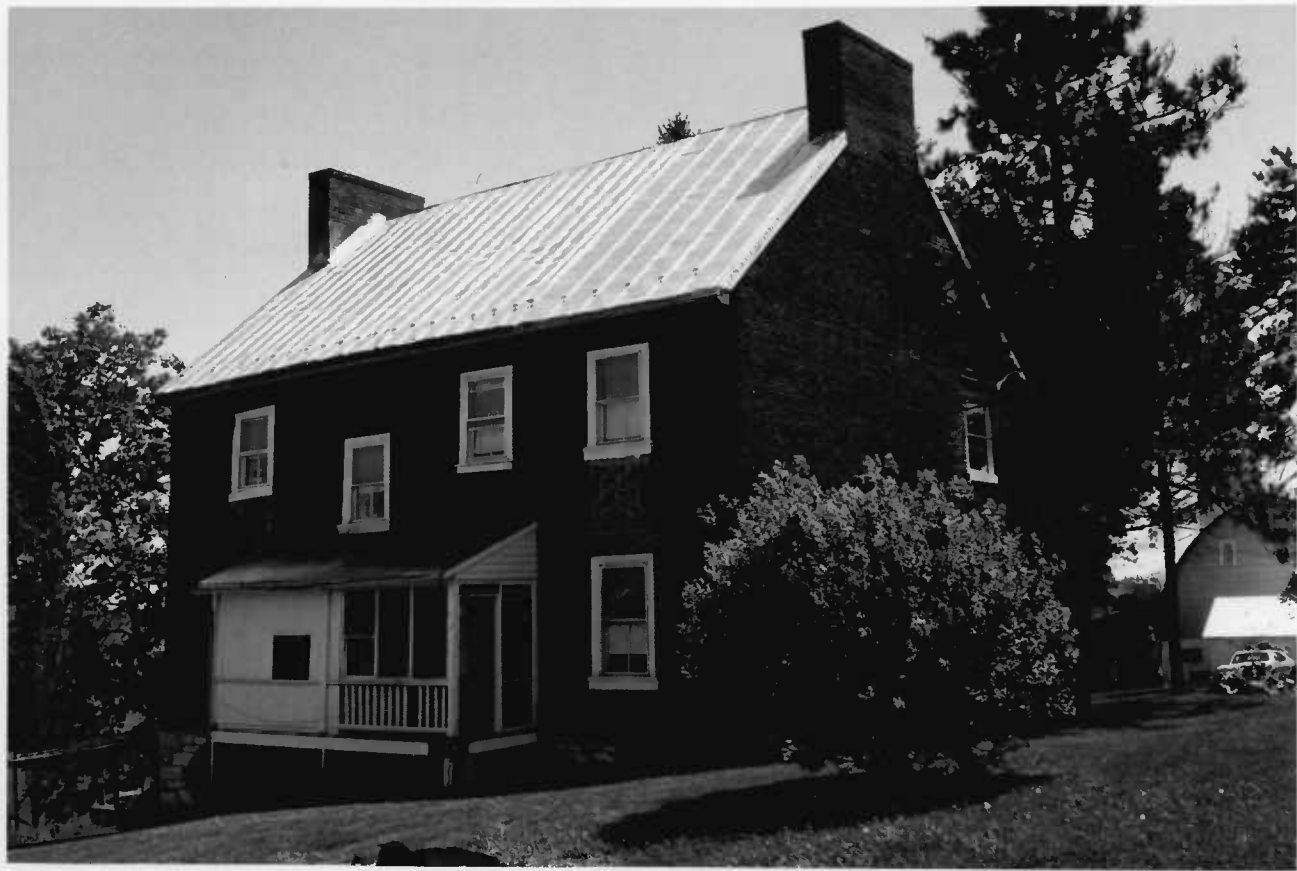
N.W.

The dwelling stands on moderately high sloping ground west of Meadow Brook and faces south. It is a two story, four bay brick structure set on roughly coursed local limestone foundations which, because of the hillside location of the house are exposed a full story above ground level at the east end elevation. The bricks are laid in Flemish bond at the front and rear elevations of the house while the side walls display common bonding with, generally, five courses of stretchers between header rows. A molded quarter round brick watertable is located eight courses above the foundation at the front and rear elevations. Openings are topped with flat arches the height of one and a half bricks in length at the first story of the front and rear elevations and one brick in height at upper story and end wall windows.

A pair of doors are located in the center bays of the rear or north elevation where a small porch is attached.

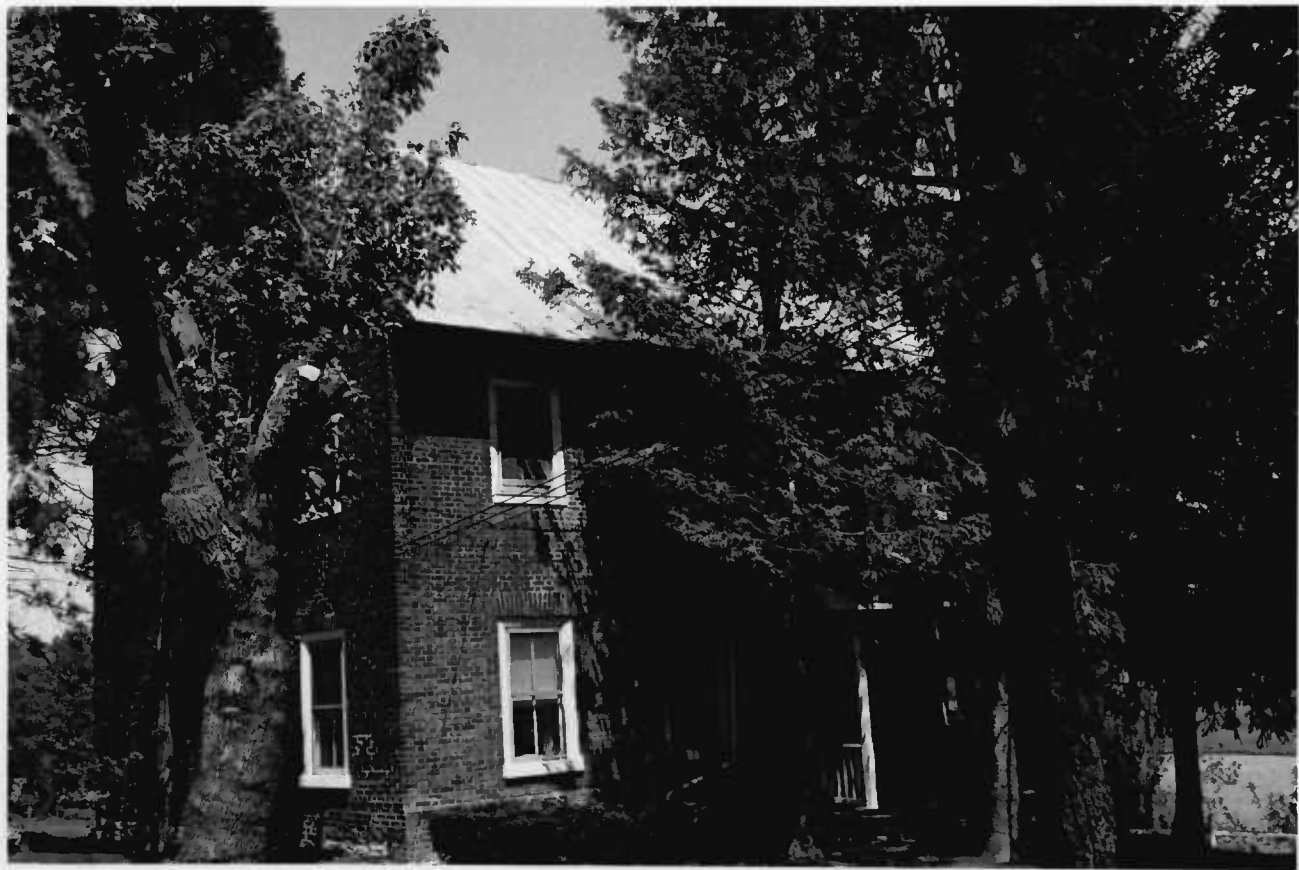
S.W.

The main entrance of the house is located in the third bay from the west end of the front or south elevation. The original door and most of the entrance woodwork were replaced during the late 19th and early 20th centuries. A one bay shed roofed porch shelters the entrance.

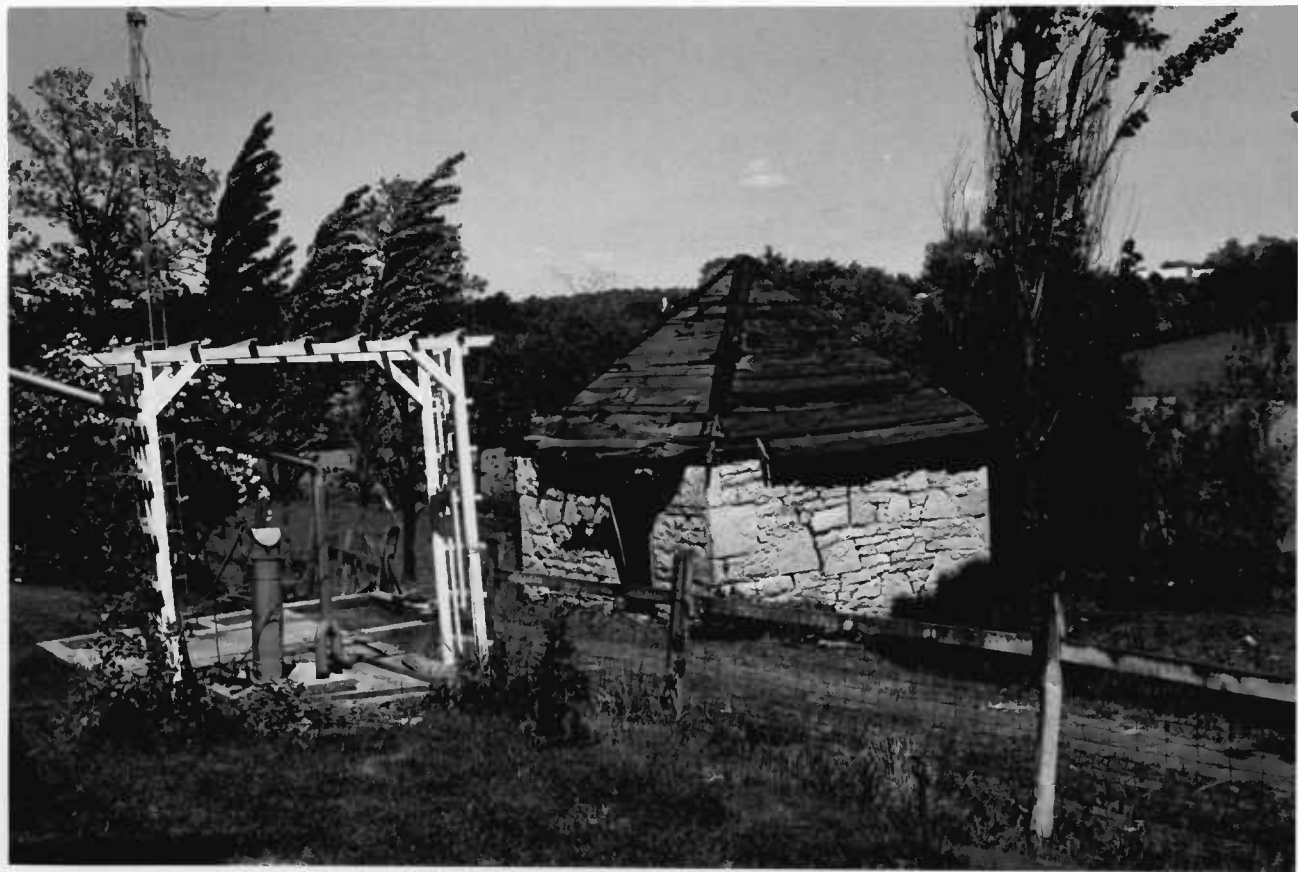
Smokehouse S.W.

Just east of the dwelling is a smoke house constructed of coursed limestone with a wood-sheathed hipped roof.
